THE GALILEO HIGH GAIN ANTENNA DEPLOYMENT ANOMALY

Michael R. Johnson *

ABSTRACT

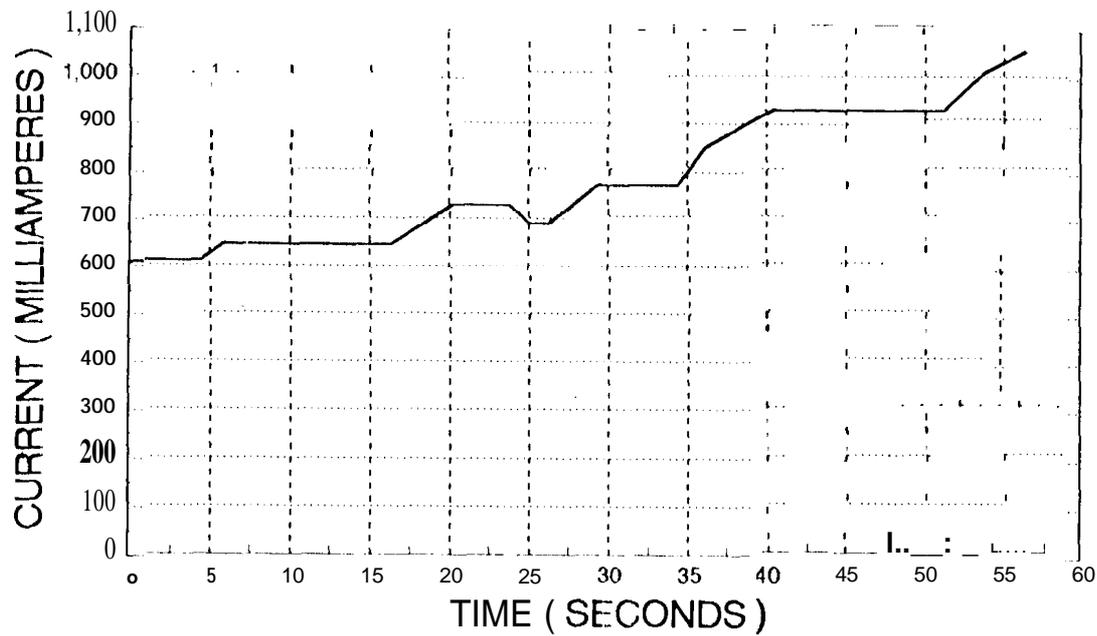
Figure 11.
 Motor Current Telemetry
 (Start : 19: 51:23 spacecraft time)

overheating (if stalled) and to allow enough time for a single motor operating at cold temperature to fully deploy the antenna. The motor current telemetry received from the spacecraft is shown in Figure 11. The current drawn by the motors started higher than expected and continued to rise until it leveled off 56 seconds after initiation,

The motor current telemetry indicated that the motors stalled at 56 seconds after initiation. The telemetry was then used to determine how far the ballscrew in the Mechanical Drive System had rotated from the stowed position. The motors on the DDA are brushless dc motors. The DDA, therefore, has the speed-torque-current relationship shown in Figure 14.

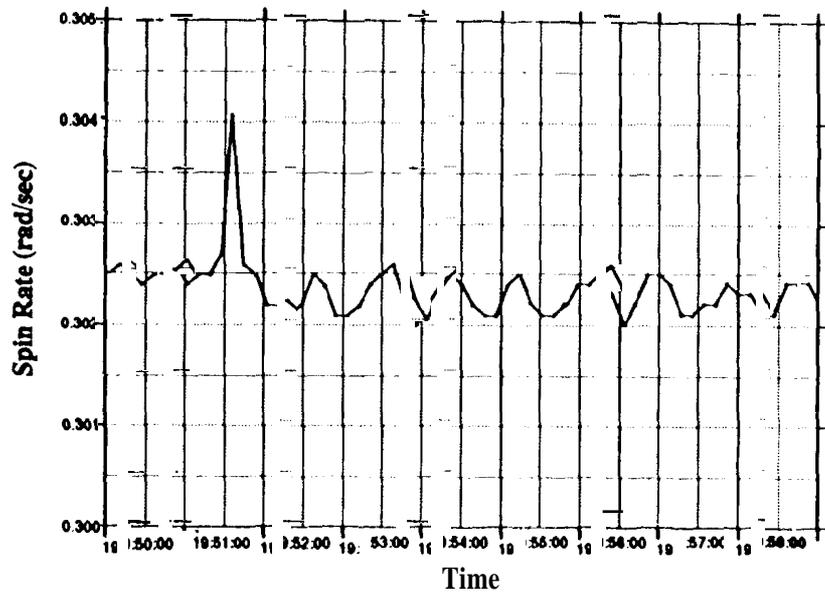
Figure 12.
 Spin Detector Telemetry

increase in the wobble of the spacecraft. The Spin Detector is a very sensitive accelerometer mounted on the spinning portion of the spacecraft. This sensor is used to detect the spin rate of the spacecraft. At eight seconds after the start of the deployment, a sudden acceleration occurred and produced the Spin Detector output spike shown in Figure 12. Figure 13 shows the output of the Sun Gate after the deploy attempt. The Sun Gate is a detector that is used to protect the spacecraft from exceeding an angle of 15 degrees between the sun and Galileo's long axis. This was necessary to protect the Galileo during the portion of the mission when it was close to the sun. During the HGA deploy attempt, the Sun Gate output dropped at a spacecraft clock angle

The Spin Detector spike occurred at a time in the deployment that coincided with an increase in torque for the DDA. The initial thinking that the spike was due to the release of some other restrained ribs was not consistent with the increase in torque required from the drive system.

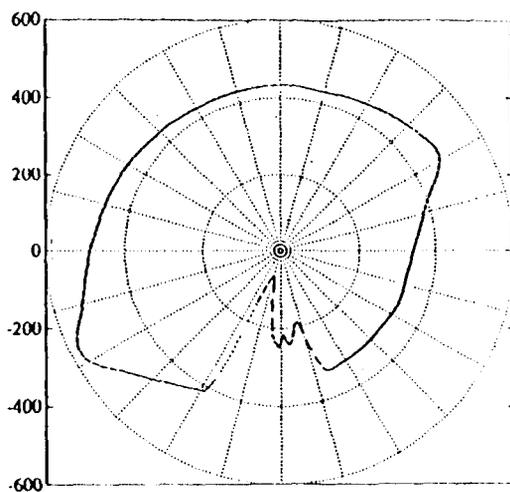
Figure 13.

of 265 degrees. The clock angle is an angular position measurement on the spacecraft with the origin at the rotational center of Galileo and in a plane perpendicular to the HGA long axis. Also, the decrease in spin rate was not enough for a fully deployed antenna (due to the increase in the antenna's moment of inertia) and the reason for the increase in wobble was not initially understood.

The first conclusion that can be drawn from the Sun Gate data is that the output was reduced by the shadow of an antenna rib. Analysis of the Sun Gate's location with respect to the antenna shows that only one rib can shadow the Sun Gate and that this rib can only shadow it at deployment angles of 34 to 43 degrees given the spacecraft-to-sun angle at the time of the deploy attempt (5.39 degrees). Analysis of the amount of obscuration of the Sun Gate indicated that the one rib that can shadow the Sun Gate was deployed about 35 degrees from its stowed position.

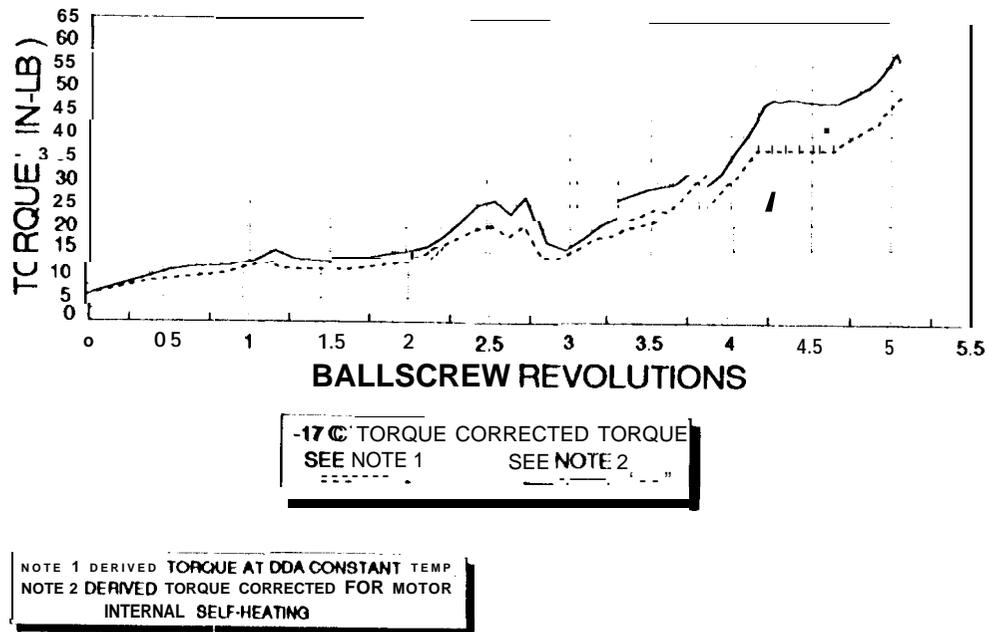
Figure 15.
Torque vs. Ballscrew Revolutions
for the High Gain Antenna Deployment Anomaly

This allows the expression of speed as a function of current. Utilizing this relationship, the current telemetry from the spacecraft, and integrating over time allowed the determination of the ballscrew position as a function of time. Taking into account the granularity of the current telemetry, converting the current telemetry to torque, and plotting this as a function of ballscrew revolutions resulted in the curve shown in Figure 1 S. The data indicates that the ballscrew rotated just over five turns. (A full deployment requires 25 rotations of the ballscrew.) Converting the five rotations to carrier movement and then to rib rotation indicates that the ribs could not have deployed to an angle greater than 11 degrees, which is inconsistent with the Sun Gate data. The way the ribs are connected to the carrier allows for an asymmetric deployment of the ribs if one or more ribs are restrained by something. After several tests on the spare antenna, it was determined that the most likely configuration of the antenna was three ribs restrained at their stowed position. This would allow the opposite rib (over the Sun Gate) to deploy to the position indicated by the Sun Gate data. Also, the number of ballscrew revolutions and the torque required to deploy the antenna under these conditions is consistent with the current telemetry. Figure 16 is a photograph of the spare antenna in the three restrained rib configuration. This asymmetrical configuration is also consistent with the amount of reduction in the spin rate and the increase in wobble.

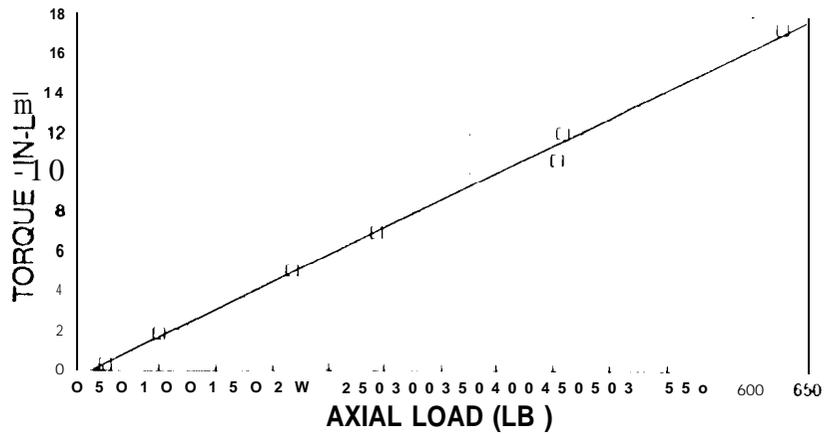
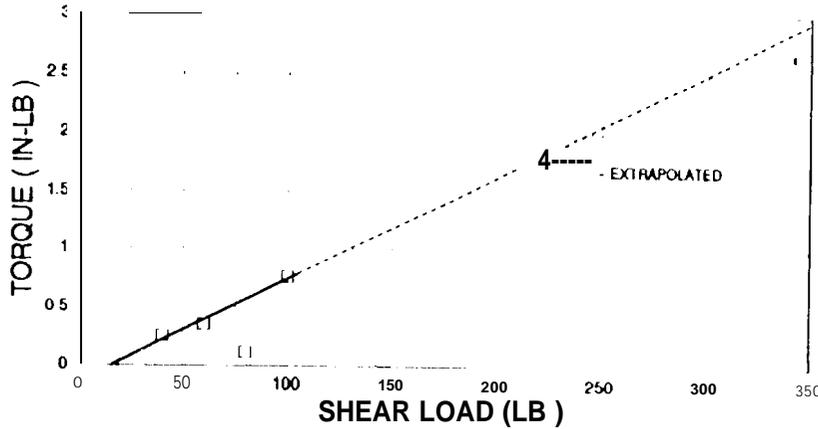
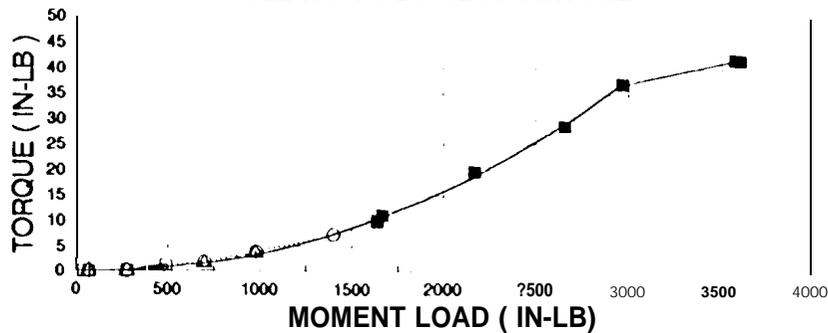
Figure 18.
Mechanical Drive System
Test Fixture Results
 (Torque required to turn ballscrew with the specified loads applied)

bearing housing (see Figure 5), due to the sliding contact of the ballscrew with the stationary outer housing. The needle roller bearing in the lower housing is not capable of supporting a large moment load, allowing the ballscrew to rotate relative to the housing and come in contact with it. The result of these torque losses was that very little torque was available to move the ribs against their restraints. -

was about 6.33 N-m (56 in-lb). A test was performed on a mock-up of the MDS to determine how it would respond to the odd loading condition created by the antenna. The test fixture shown in Figure 17 was used to apply moment, axial, and shear loads to the "carrier plate" individually and in combination. The results of these tests showed that shear and axial loads do not significantly affect the efficiency of a ballscrew. Moment loads, however, result in very significant losses in a ballscrew/ballnut assembly. The graphs in Figure 18 show that the application of a moment of 339 N-m (3000 in-lb) to a ballnut results in torque losses of 4.18 N-m (37 in-lb), or more than half of the available torque from the DDA. This large amount of torque loss is due to jamming of the balls in the ballnut and sliding contact of the ballscrew with the ballnut body. Also, it was found that further losses occurred at the lower

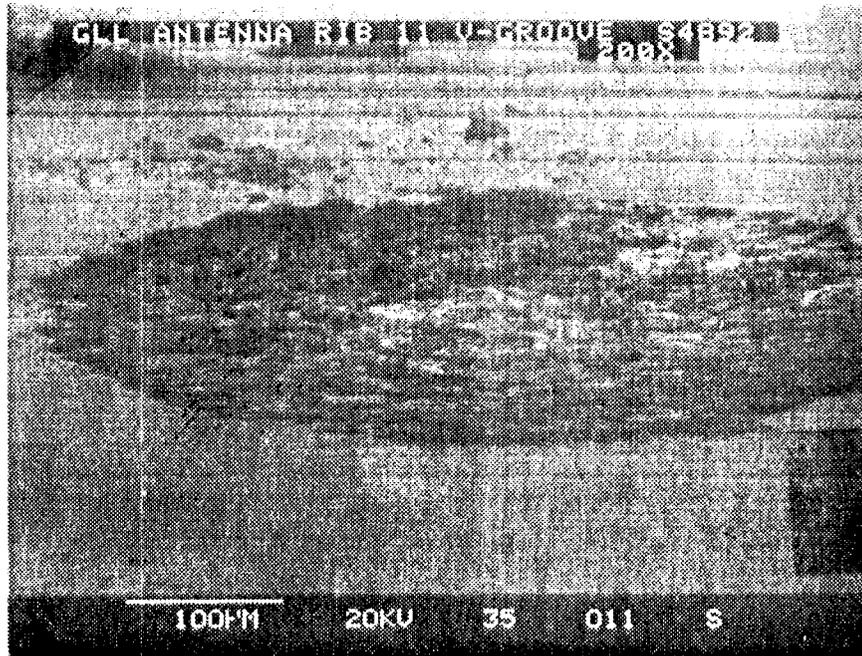
Figure 21.
Magnification of Upper Spot
on V-Groove Socket in Figure 20

deformed and worn away. Scans of the contact surface on the receptacle show a large amount of Ti 6Al-4V, indicating a transfer of base material from the titanium pin.
